Templeton-Whitney Grazing Allotments, Golden Trout Wilderness

Head Cut and Photo Point Monitoring, 2003 and 2010 (DRAFT)

By: Casey Shannon, Hydrologic Technician

Inyo National Forest, Supervisor's Office

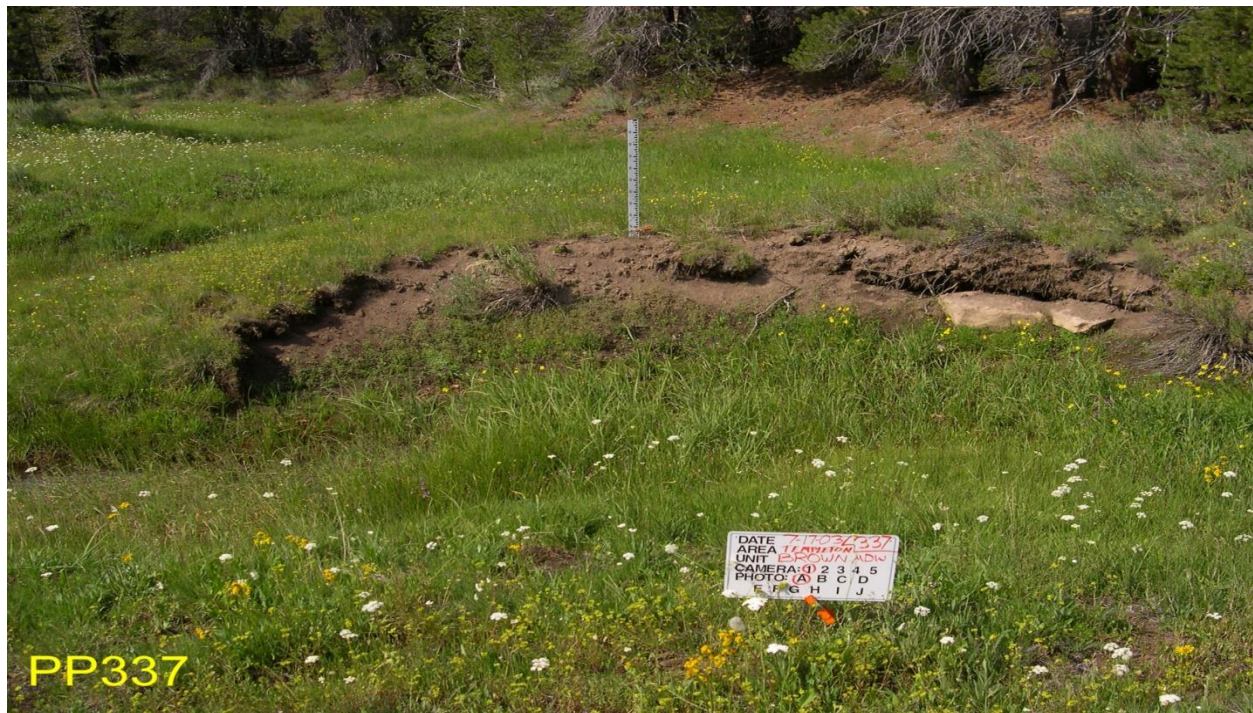
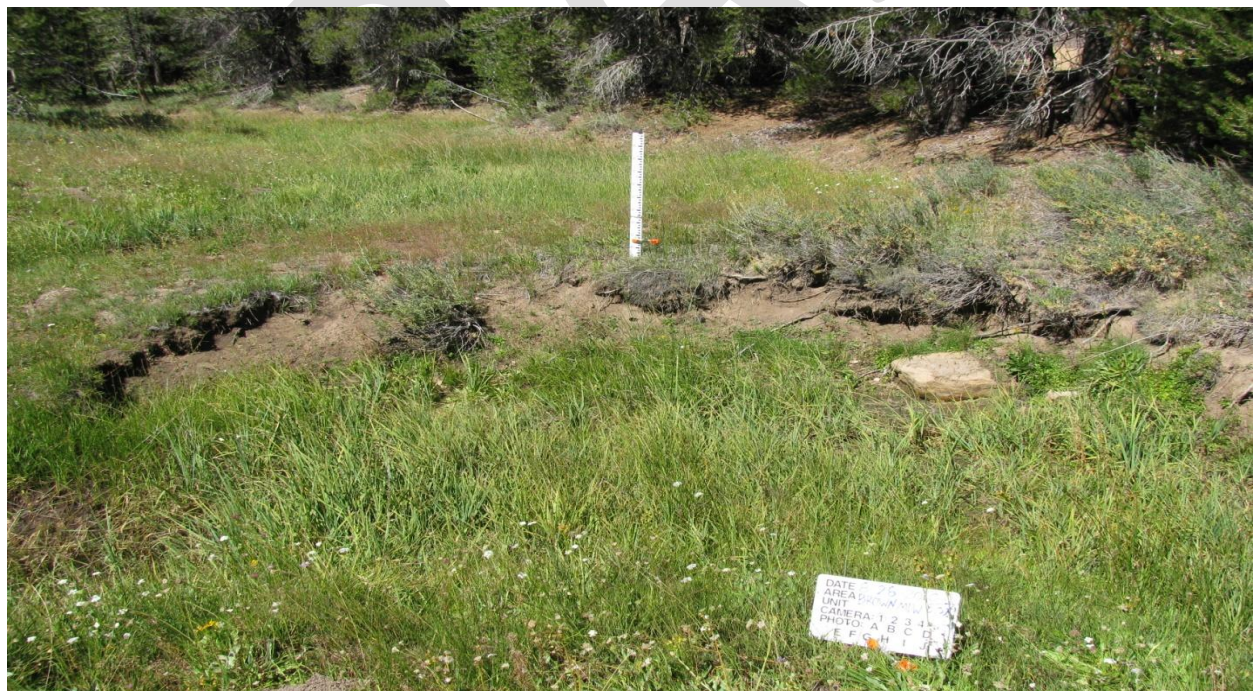
Above photo: Photo-point 337 (PP-337), upper Brown Meadow above cow camp, July 2003. Site is a degraded stream bank with missing soil and sod layer. **Below photo:** PP-337 photo re-taken August 2010. Riparian vegetation has moved upslope on bare soil area and starting to fill in. This is indicative of the water table rising and aggrading floodplain. The site is still vulnerable to erosion from disturbance but is in an upward trend.

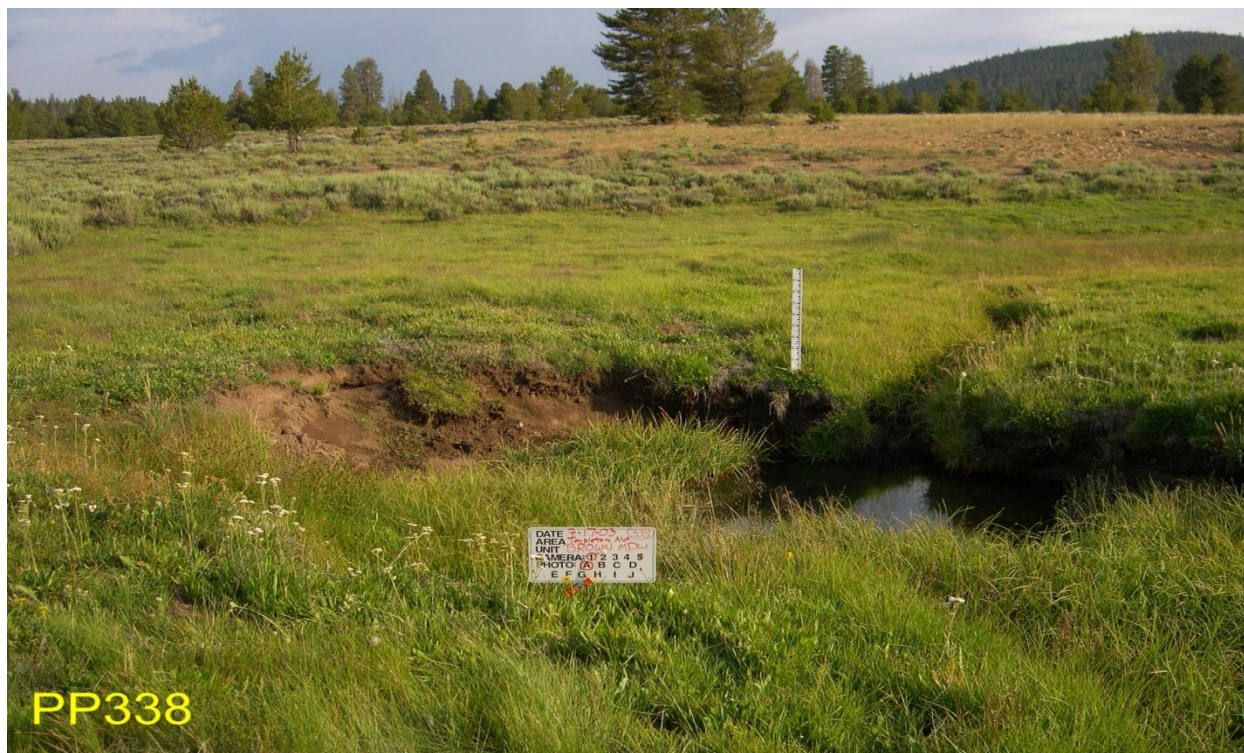
Above photo: Photo-point 338 (PP-338) Brown Meadow, July 2003. Site has an eroding scour pool with a small head cut and eroding banks. **Below photo:** PP-338 Brown Meadow with photo re-taken August 2010. Not a lot of noticeable change. Banks have started to stabilize with new vegetation. The scour pool has become larger and the surrounding banks are bare and slightly more unstable than in 2003. The HC has migrated only 0.50 meters. The site over time should find equilibrium and stabilize, but it still vulnerable to outside disturbance that may continue instability.

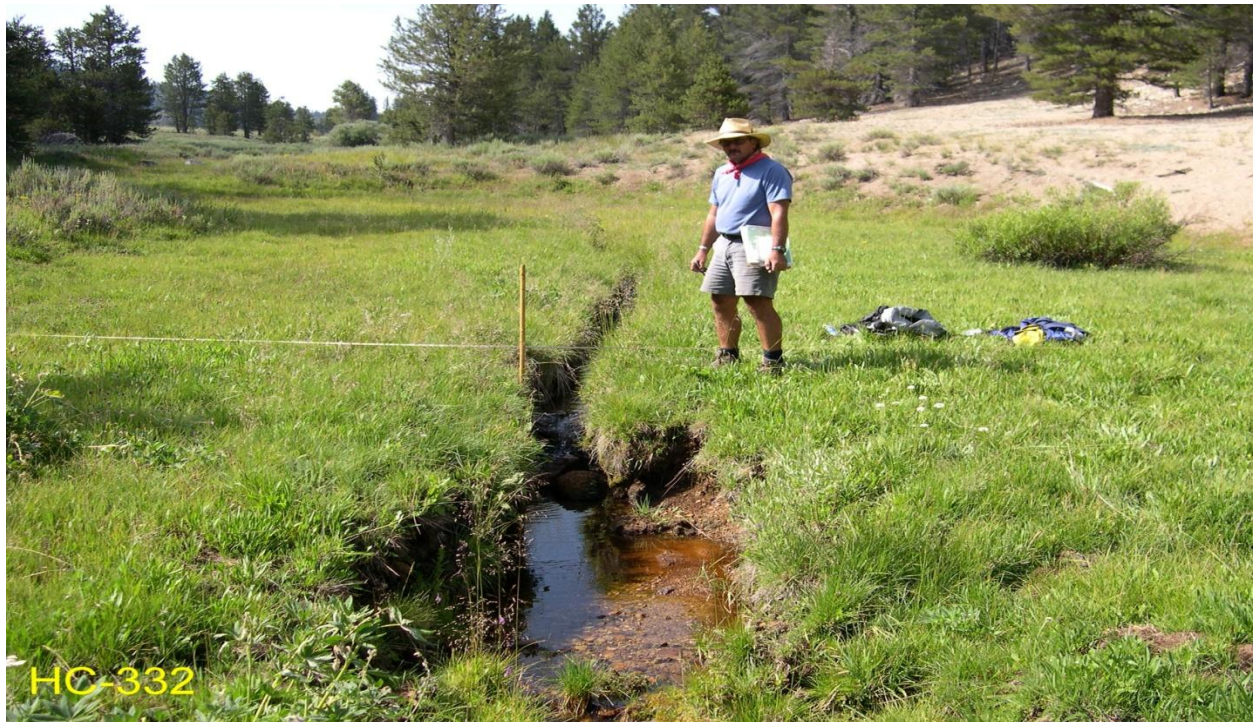
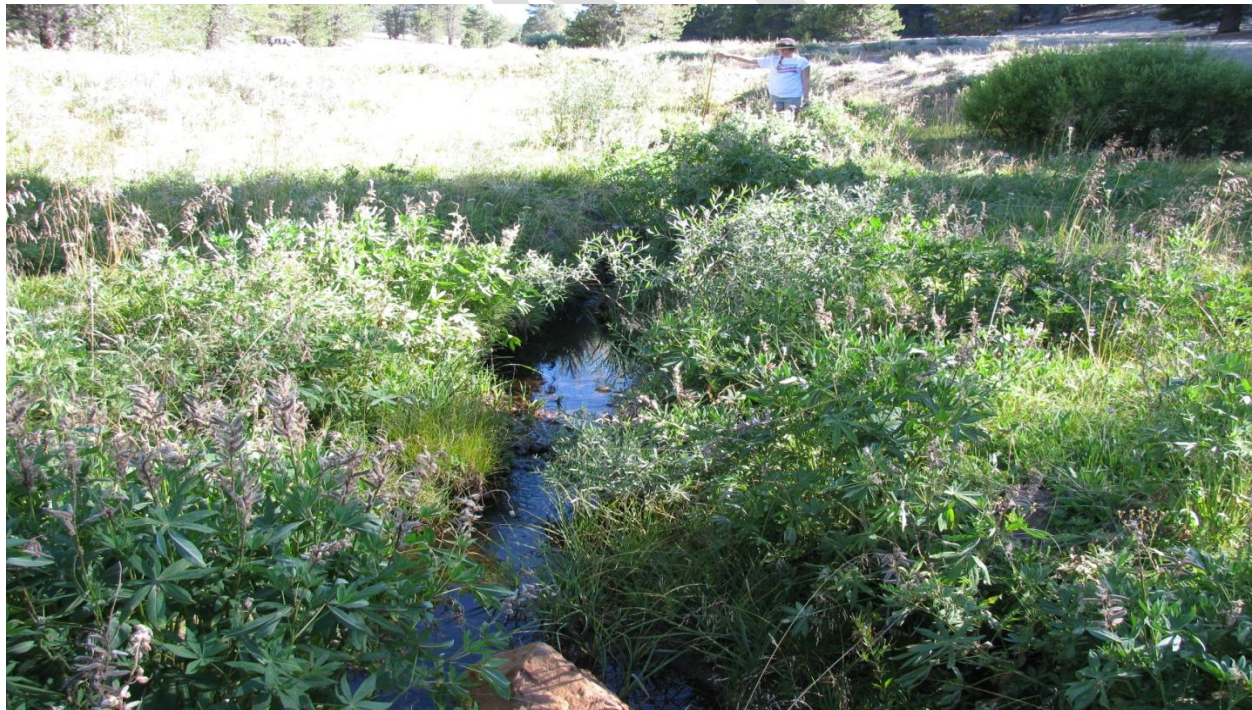
Above photo: Head cut 332 (HC-332) Brown Meadow, July 2003. HC-332 is a small in-channel HC that has caused moderate gully formation below. **Below photo:** HC-332 Brown Meadow photo re-taken August 2010. HC has migrated 5.79 meters since 2003. At the time of repeat monitoring, it appears the head cut has run its course and has begun to reach equilibrium with the natural gradient of the meadow. A moderately deep gully (approximately 0.70 meter depth by 2.1 meter width) exists below HC for a short distance and banks are moderately undercut below the rooting zone. Future threat of rapid HC migration at this site is low to moderate. Strong riparian vegetation and soil structure should slow erosion.

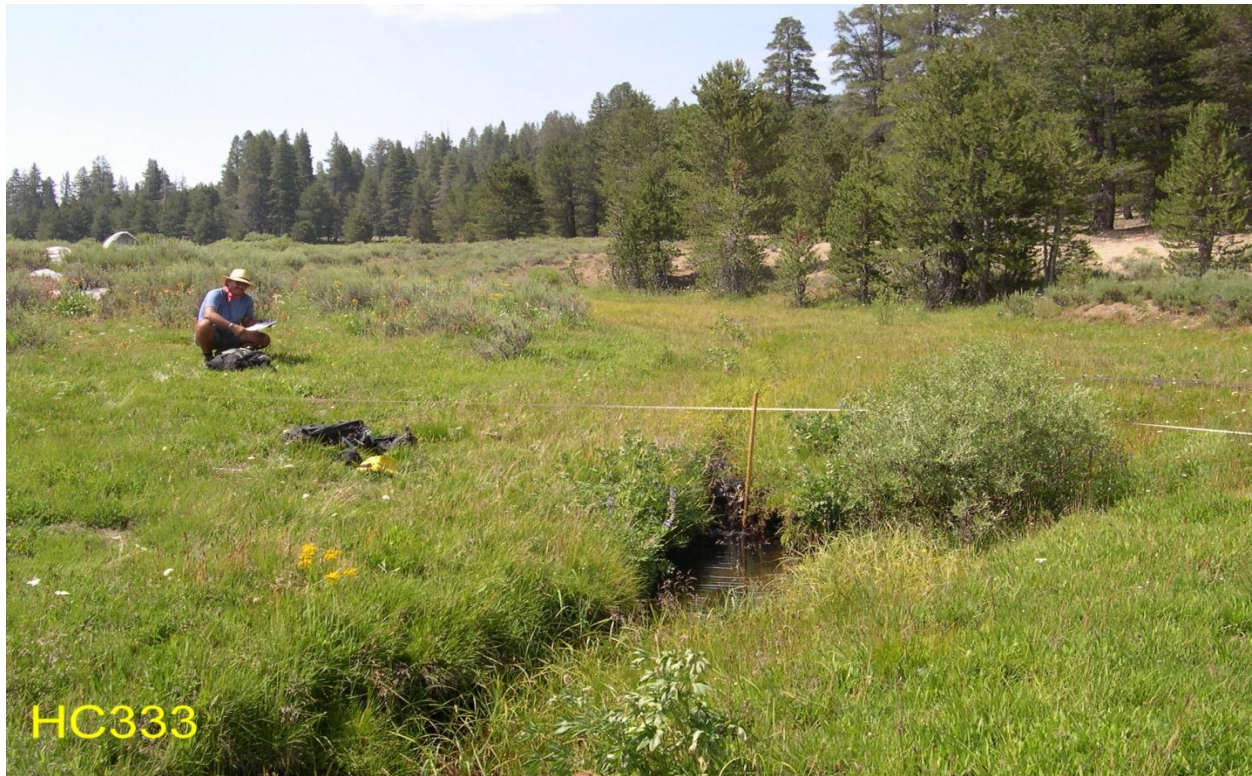
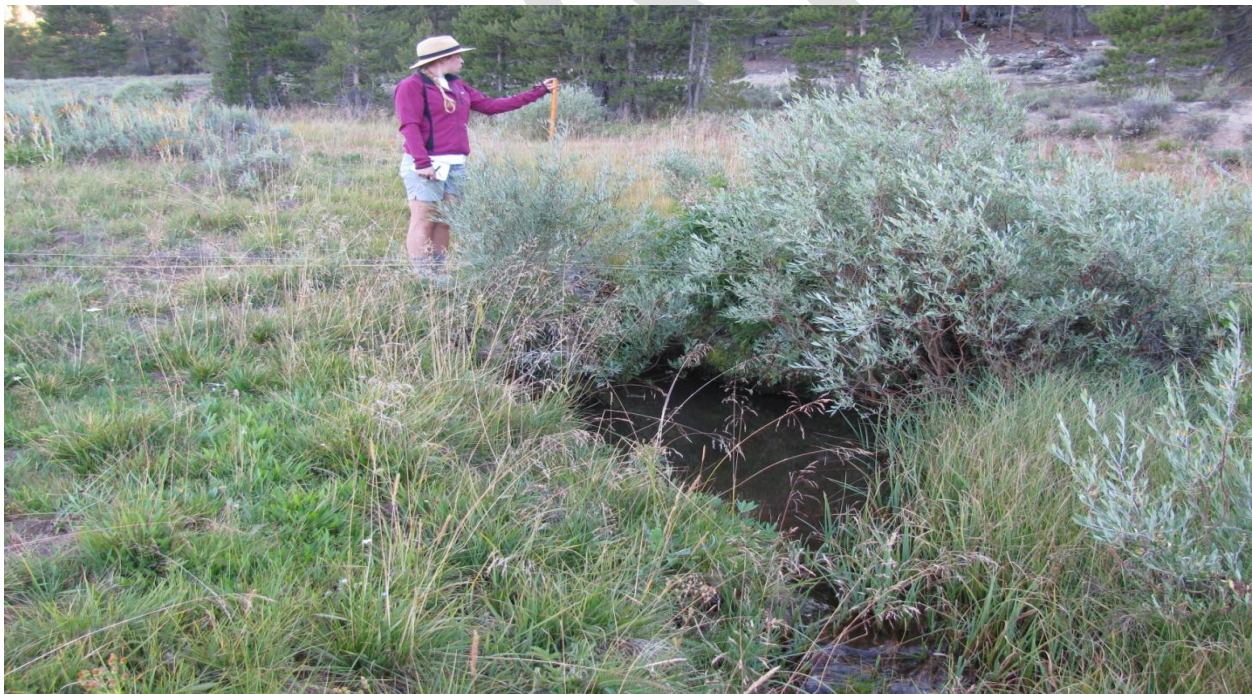
Above photo: Head cut 333 (HC-333) Brown Meadow, July 2003. HC 333 is a small head cut in the main channel of Brown Creek. **Below photo:** HC-333 Brown Meadow photo re-taken August 2010 from same site. HC had migrated < 1 meter, likely due to well-developed vegetation on stream banks and good rooting depth along channel that slows erosion. Vegetation is more robust and active than in 2003. Head cut migration rate is slow.

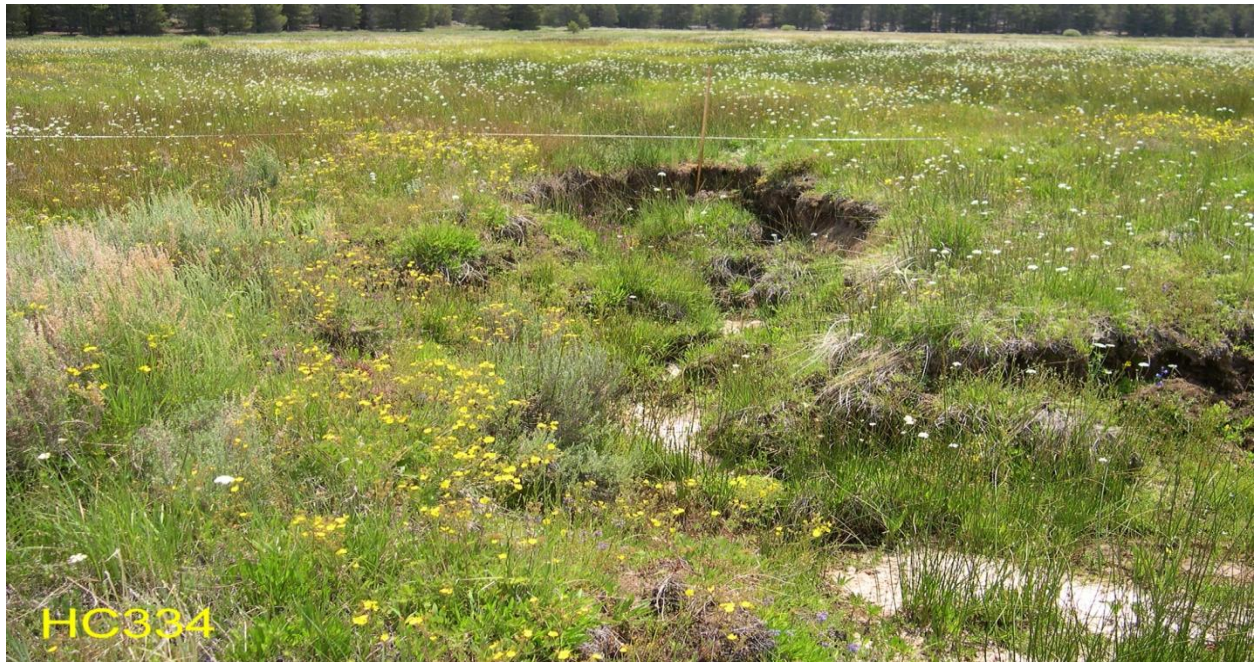
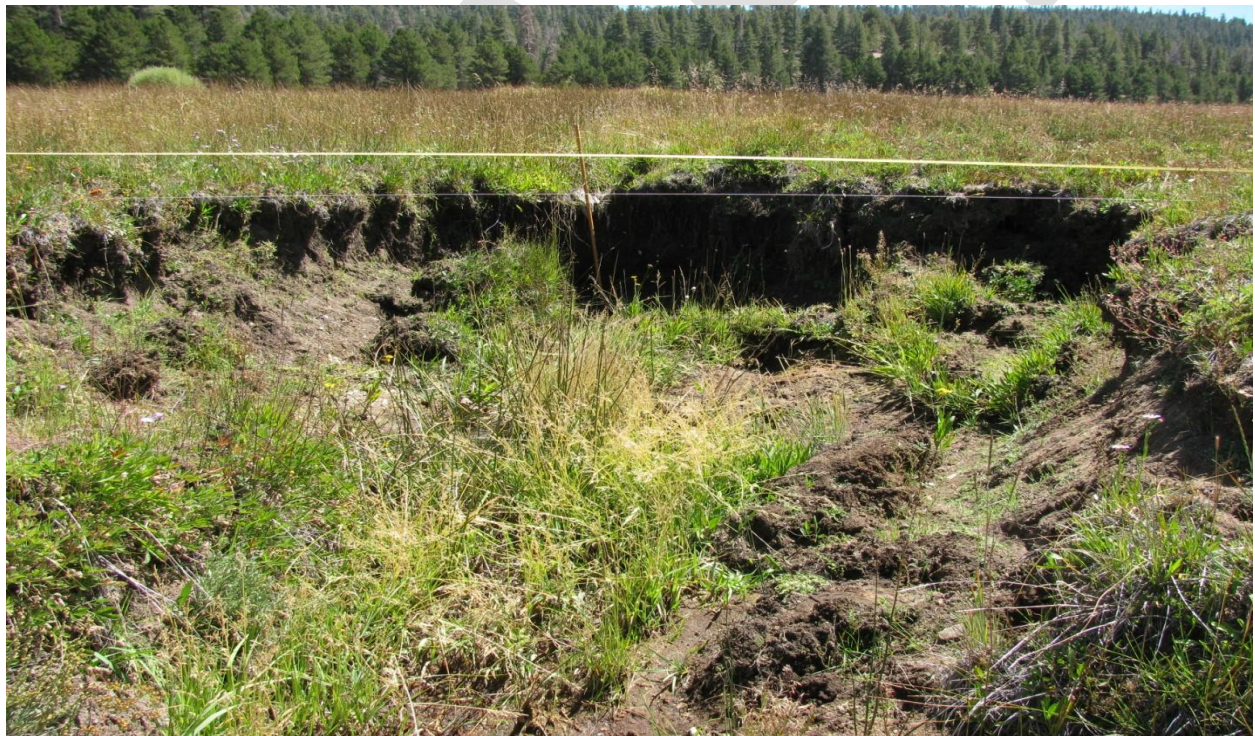
Above photo: Head cut 334 (HC-334) Brown Meadow, July 2003. Large and active HC was found in administrative pasture near cow camp. Sub soil at this site is comprised of deep, unconsolidated alluvial materials, mostly fines and erodes easily when vegetation is thin and exposed to surface runoff and groundwater sapping. Rooted vegetation (shallow organic horizon) is moderately established in this area. **Below photo:** HC-334 photo retaken August, 2010. Head cut has migrated 3.90 meters since 2003 and has approximately doubled in width and depth below the HC. This site is unstable and will likely continue to unravel rapidly as large runoff events occur and is vulnerable to additional disturbances. Careful prescription and treatment for head cut stabilization is recommended. However, a risk of treatment failure exists with the soil condition at this site.

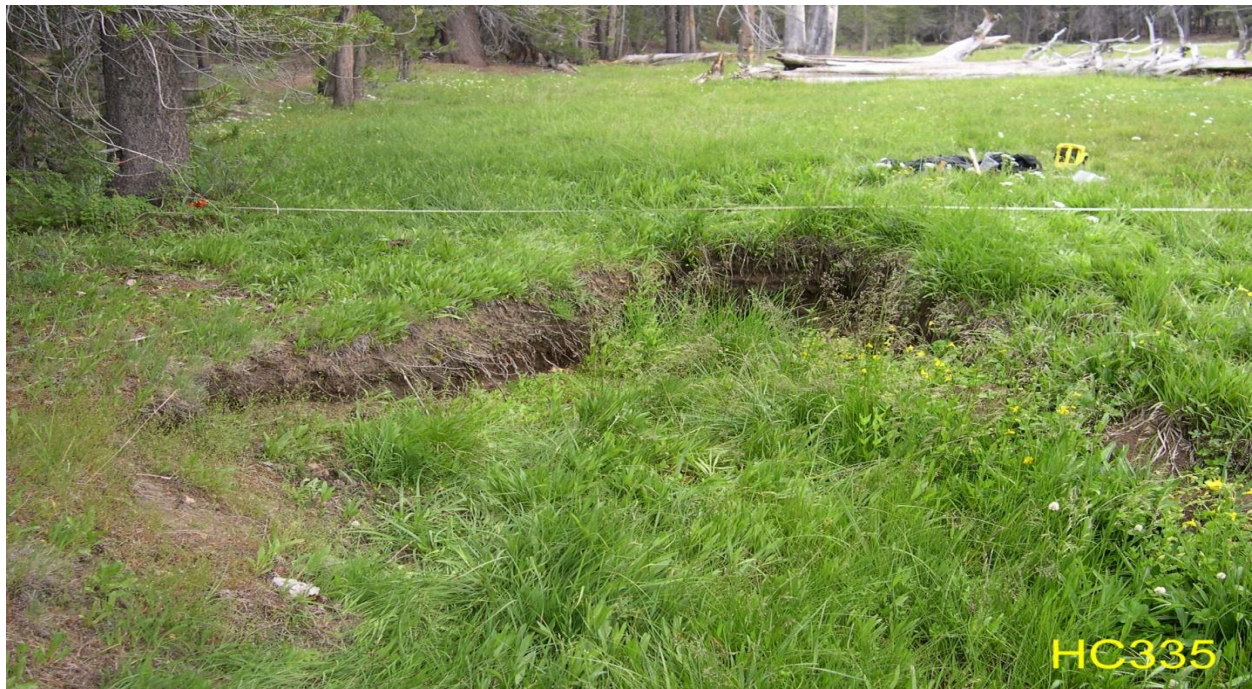
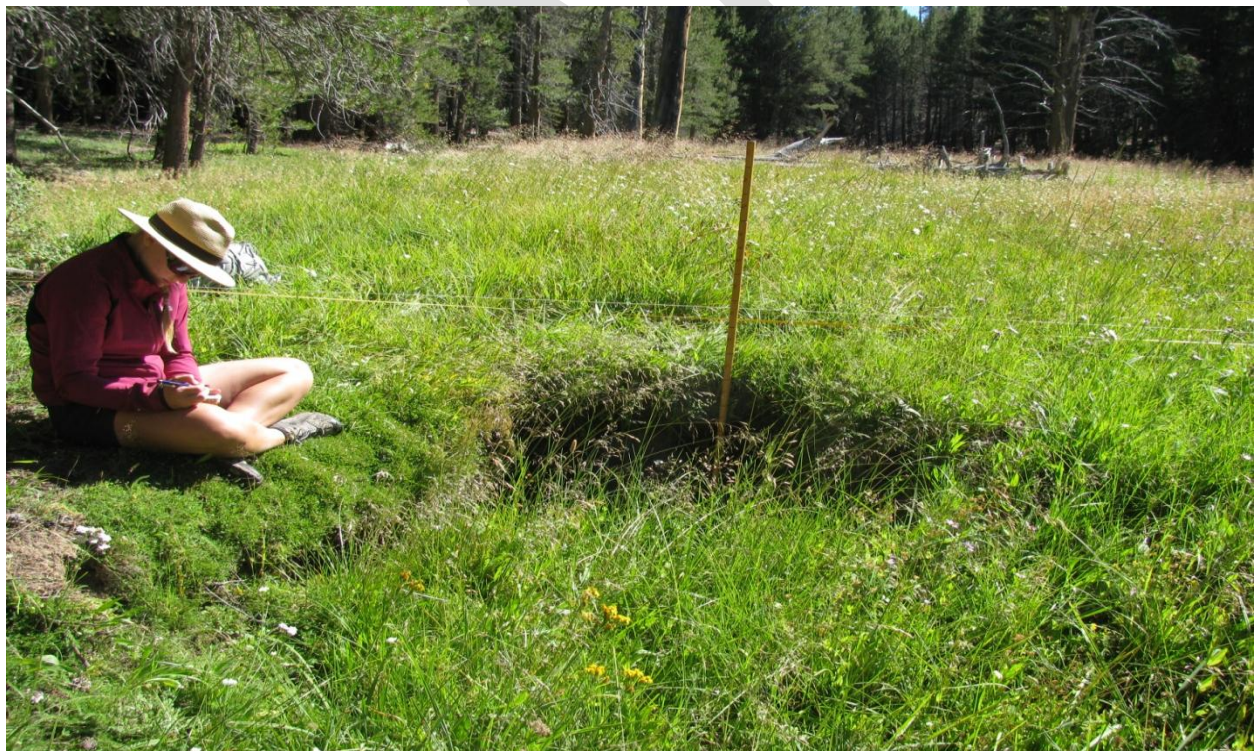
Above photo: Head cut (HC) 335, upper Brown Meadow, photo taken July 2003. This HC was set up with monuments to measure upstream migration. The head cut face and sides have exposed, rooted soil.

Below photo: HC 335 upper Brown Meadow re-taken August 2010. Head cut has not moved since 2003. Overall, the head cut face and sides are re-vegetating and stabilizing, with the gully below filling in since 2003. Organic soil is cohesive with strong vegetative roots and is resistant to erosion. Most likely this HC will continue to stabilize as it is controlled by the vigorous vegetative mat.

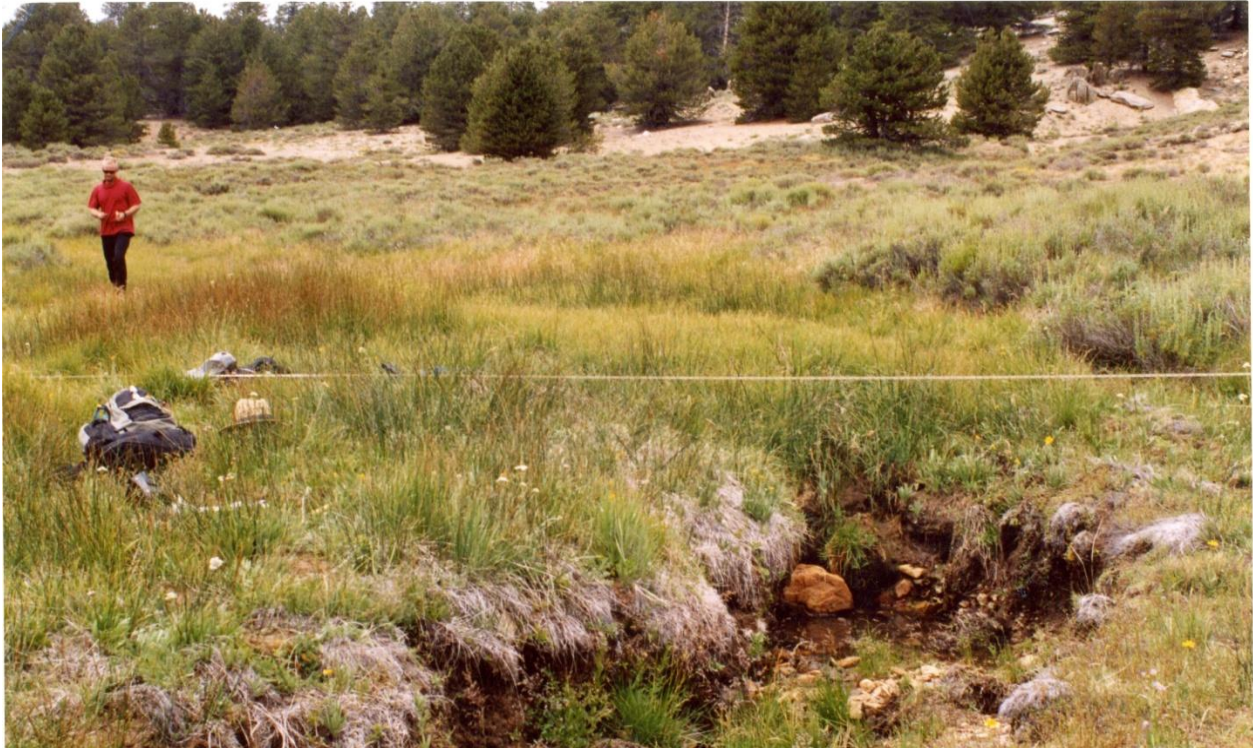
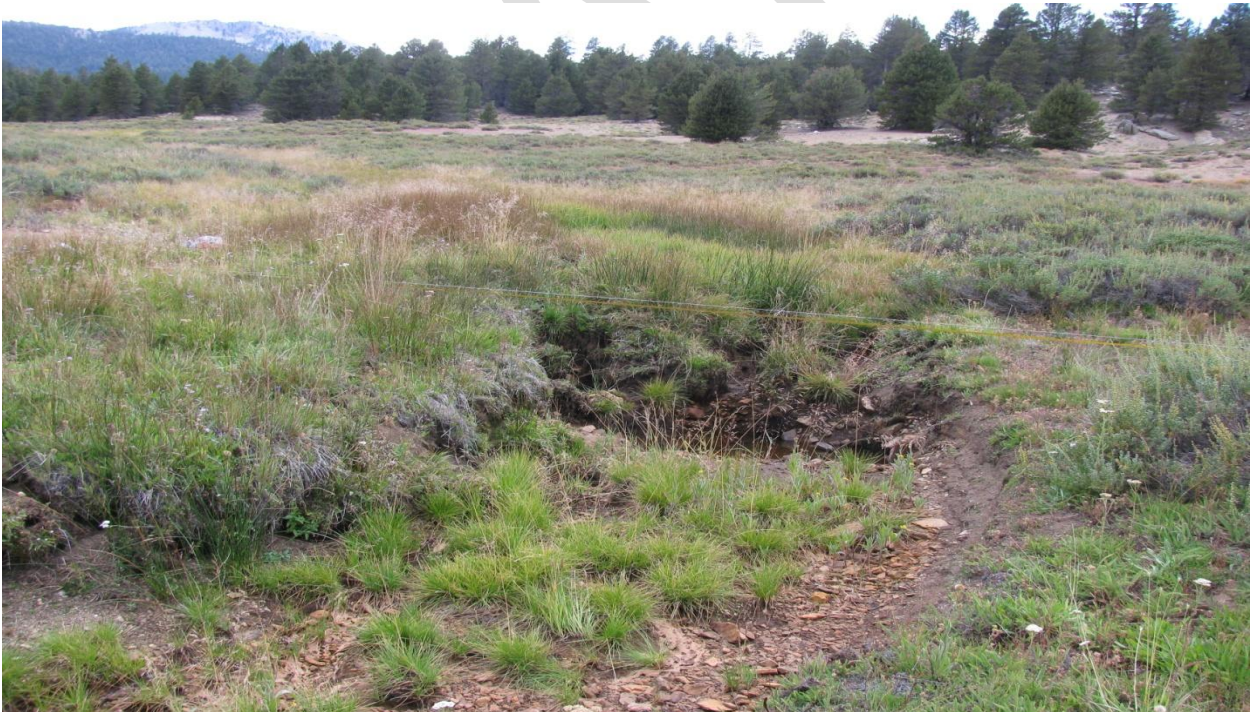
Above photo: Head cut 340 (HC 340) Lower Schaeffer Meadow, July 2003. This is a large, active HC with a wide face and incised channel migrating into floodplain area. Soil substrate is rocky with fines. Organic layer is fairly deep. **Below photo:** HC 340 Lower Schaeffer Meadow with photo re taken August, 2010. Head cut face has widened and developed into two active HC's. HC to left has migrated 1.9 meters (most active). Strong vegetation, deep root zone and rocky subsoil slow HC migration rate under typical runoff conditions.

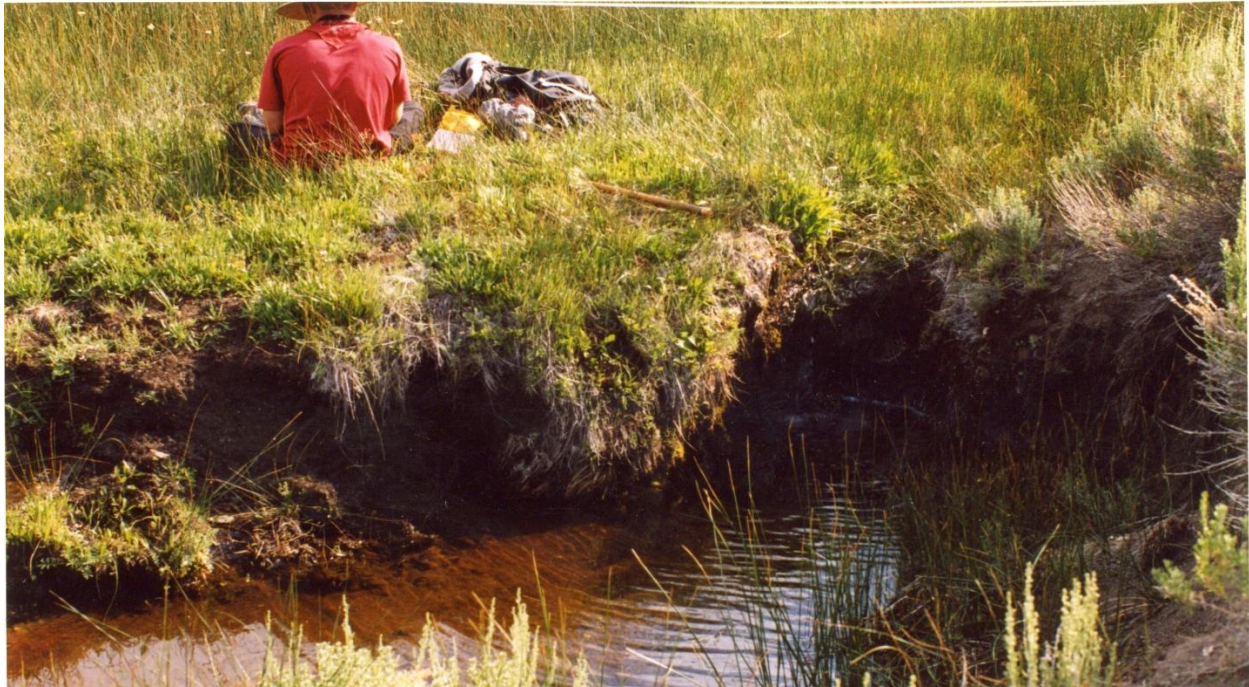
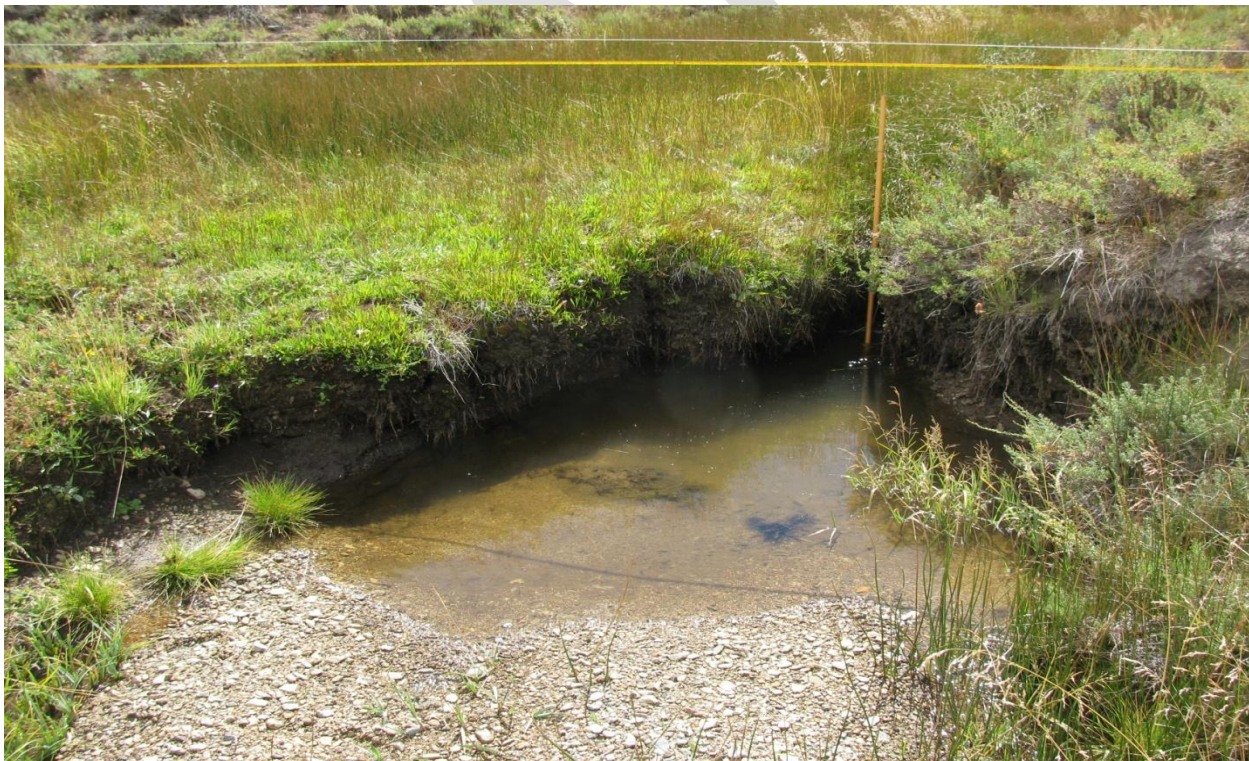
Above photo: Head cut 343 (HC 343) Upper Schaeffer Meadow, July 2003. HC 343 is a large open bowl head cut with undercut sod layer on face and incised scour pool below. **Below photo:** HC 343 upper Schaeffer Meadow with photo re taken August, 2010. HC has migrated 1.25 meters since 2003, banks along scour pool have collapsed and scour pool has widened extent. Very strong, rooted vegetation and deep organic layer have slowed HC migration. Sub soil layers are comprised of dense organic layers with intermittent layers of fines and gravel.

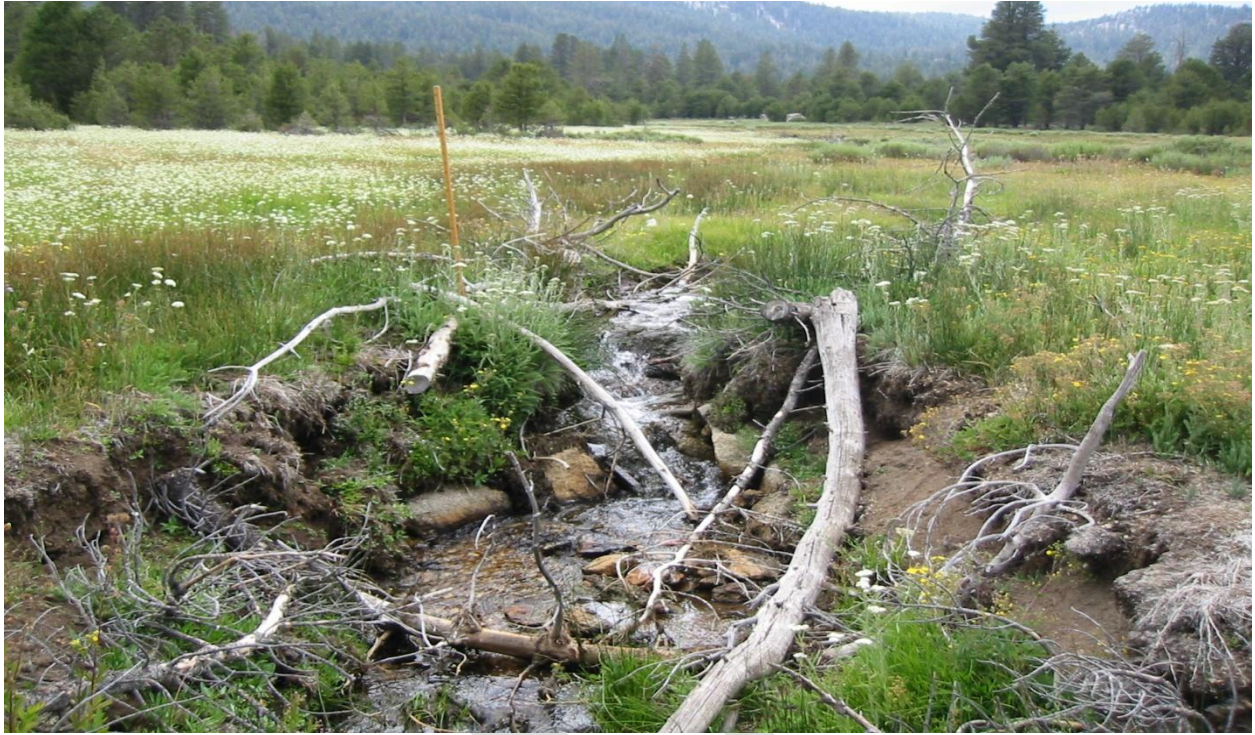
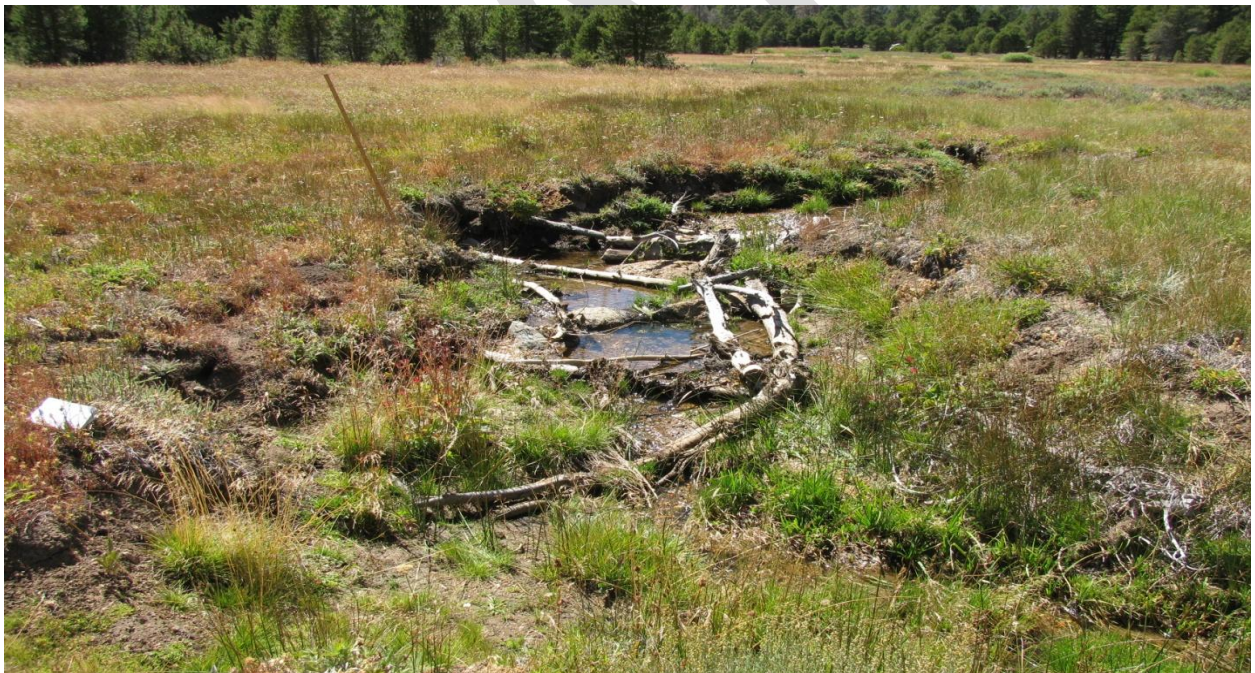
Above photo: Treated Head Cut (THC) 348, Upper Strawberry Creek ½ mile below Cow Camp, July 2003. HC was initially treated in 1998 with log headwall and rock chute and treatment held for many years. **Below photo:** THC 348 Upper Strawberry Creek, August 2010. Structure failed, was placed on meander bend, poor prescription. Organic rooted layer shallow here with loose subsoil, high erosion potential. Head cut migrated upstream 100 feet and is active, has formed a gully. With loose subsoil structure was at risk, voles contributed to bank erosion. Structure most likely failed during snowmelt peak flows of 2010. Very unstable site, stream banks are subject to additional erosion from peak flows and disturbance. Future treatment for active head cut will need further prescription analysis so to not repeat failure.

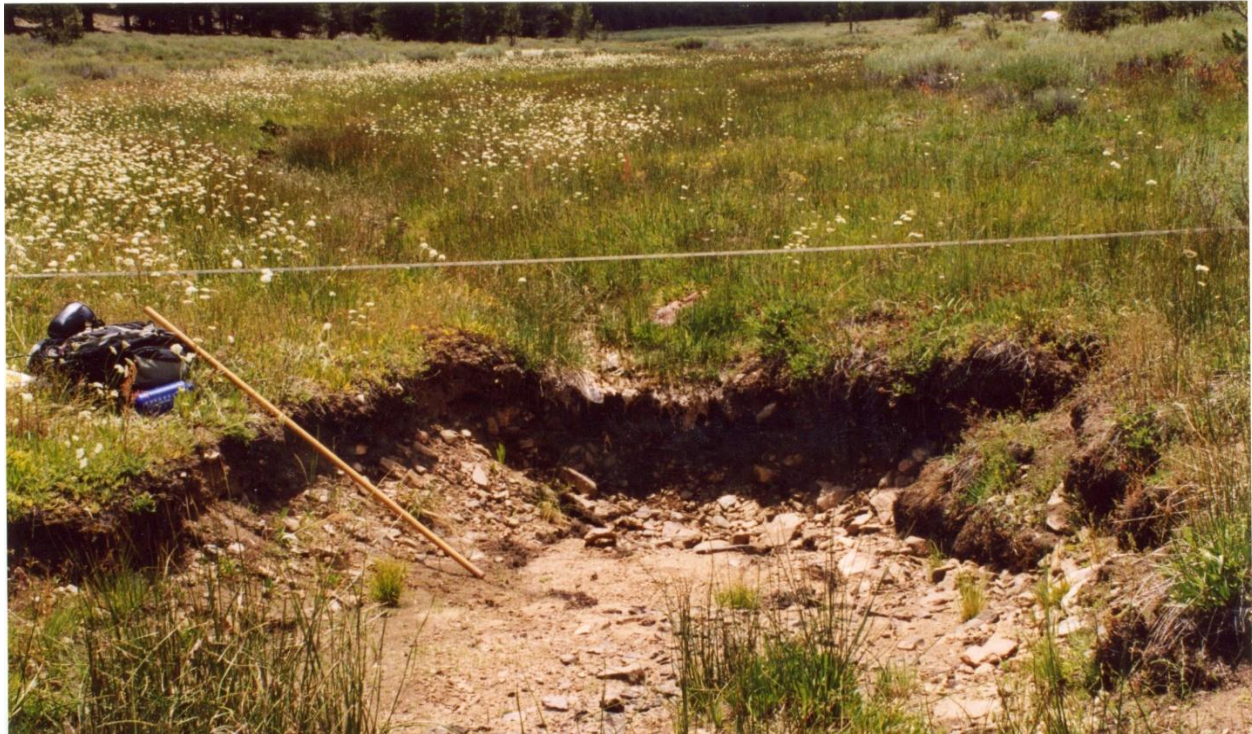
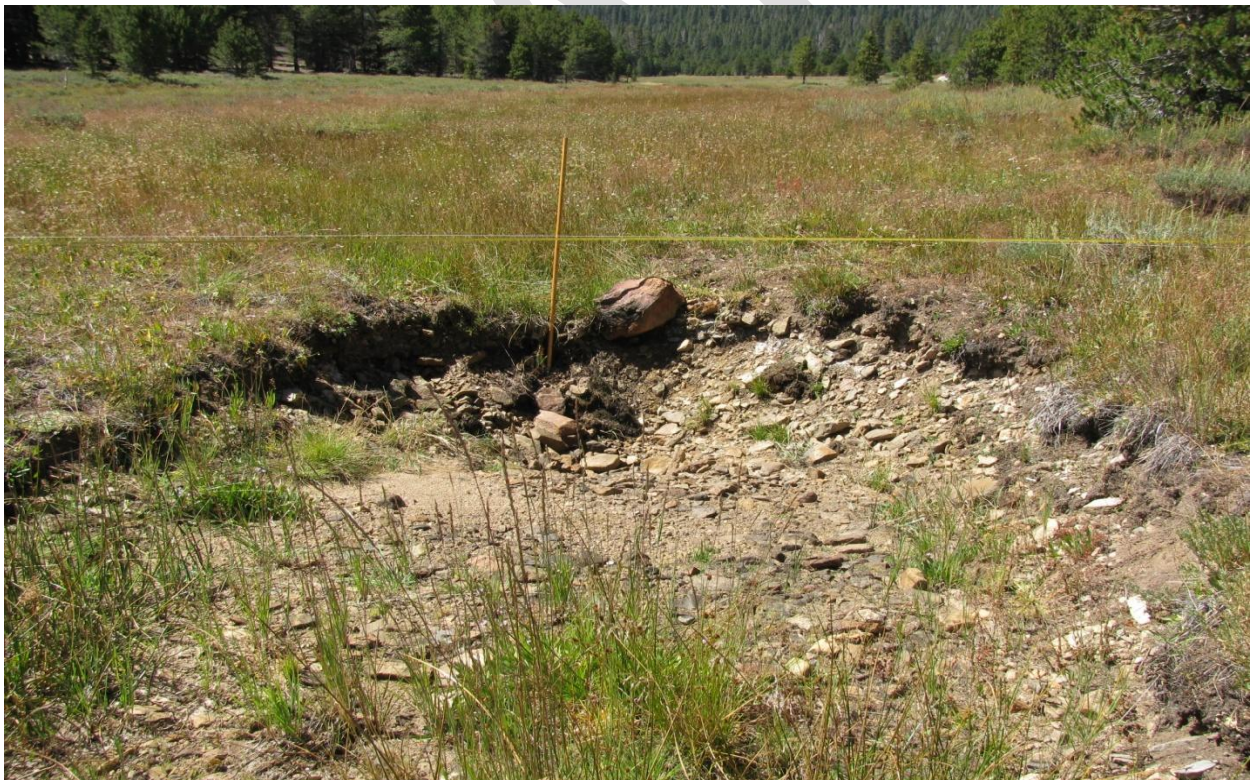
Above photo: Head cut 346 (HC 346) Fat Cow Meadow, July 2003. Wide, in channel head cut on ephemeral channel with a shallow organic horizon and deep, alluvial rocky substrate. **Below photo:** HC 346, Fat Cow Meadow with the photo re taken August, 2010. Head cut has widened slightly and migrated only 0.85 meters. Slow HC migration likely due to high amounts of cobble in subsoil and a fair vegetative cover. Flow is more overland during runoff and not channelized, thus slowing velocity and erosion potential.

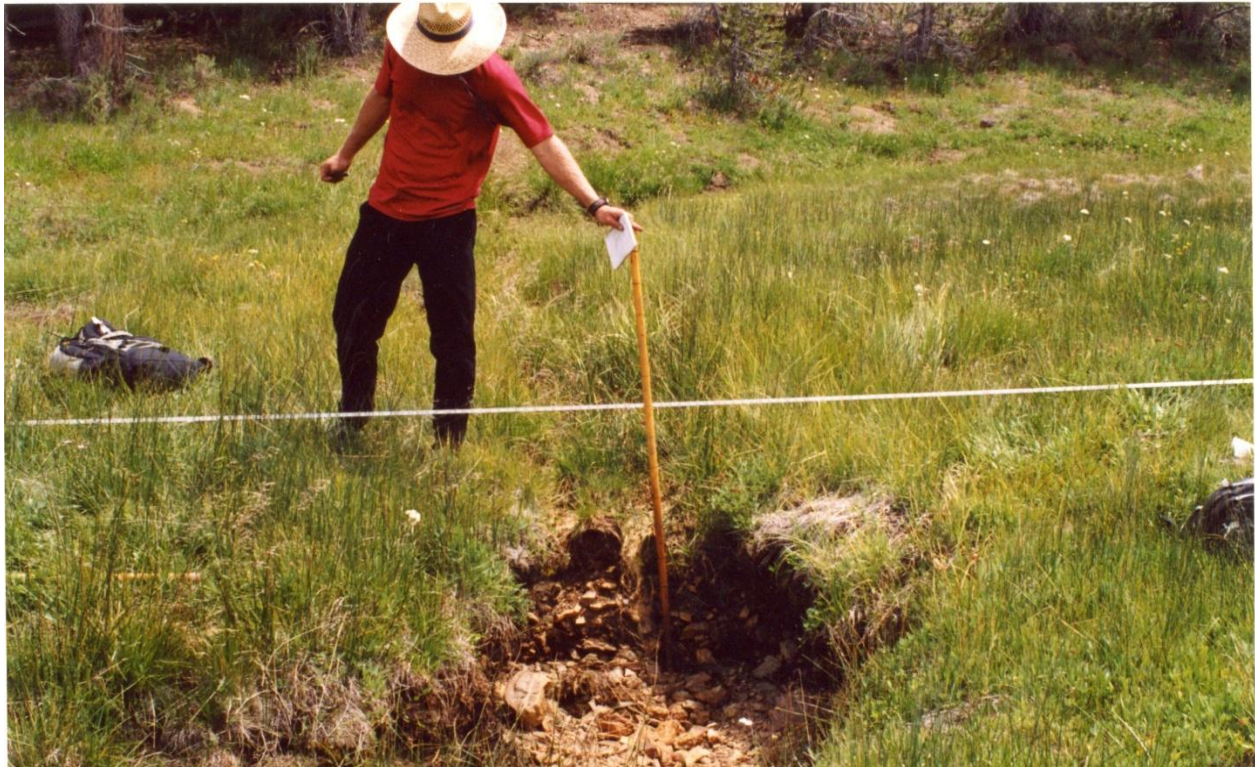
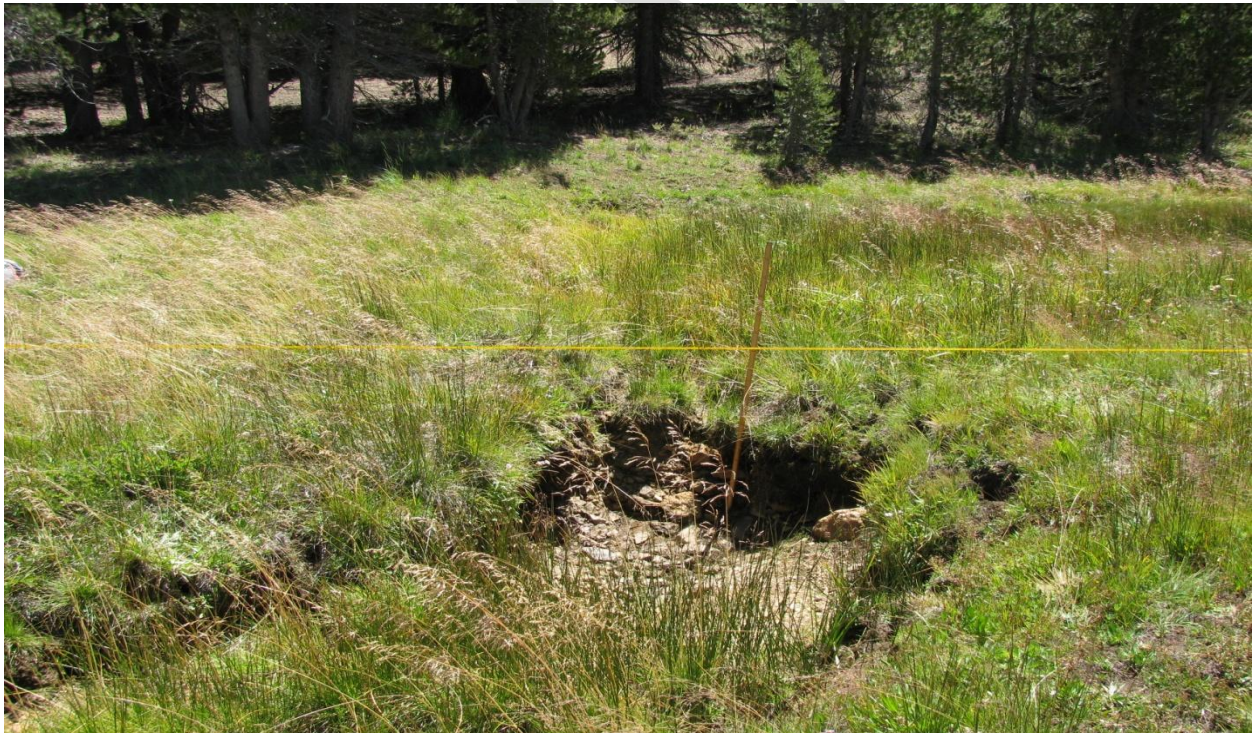
Above photo: Head cut 347 (HC 347) Fat Cow Meadow, July 2003. This site has a similar condition to HC 346 Fat Cow which is a short distance (50 meters) upstream, with moderately shallow organic horizon and deep, alluvial, non-cohesive sand and cobble substrate. **Below photo:** HC 347, Fat Cow Meadow with photo retaken August 2010. The head cut slowly migrated 0.45 meters since 2003 due to fair vegetative cover, rocky soil substrate and overland flow conditions. Riparian vegetation at site has increased and is more robust.

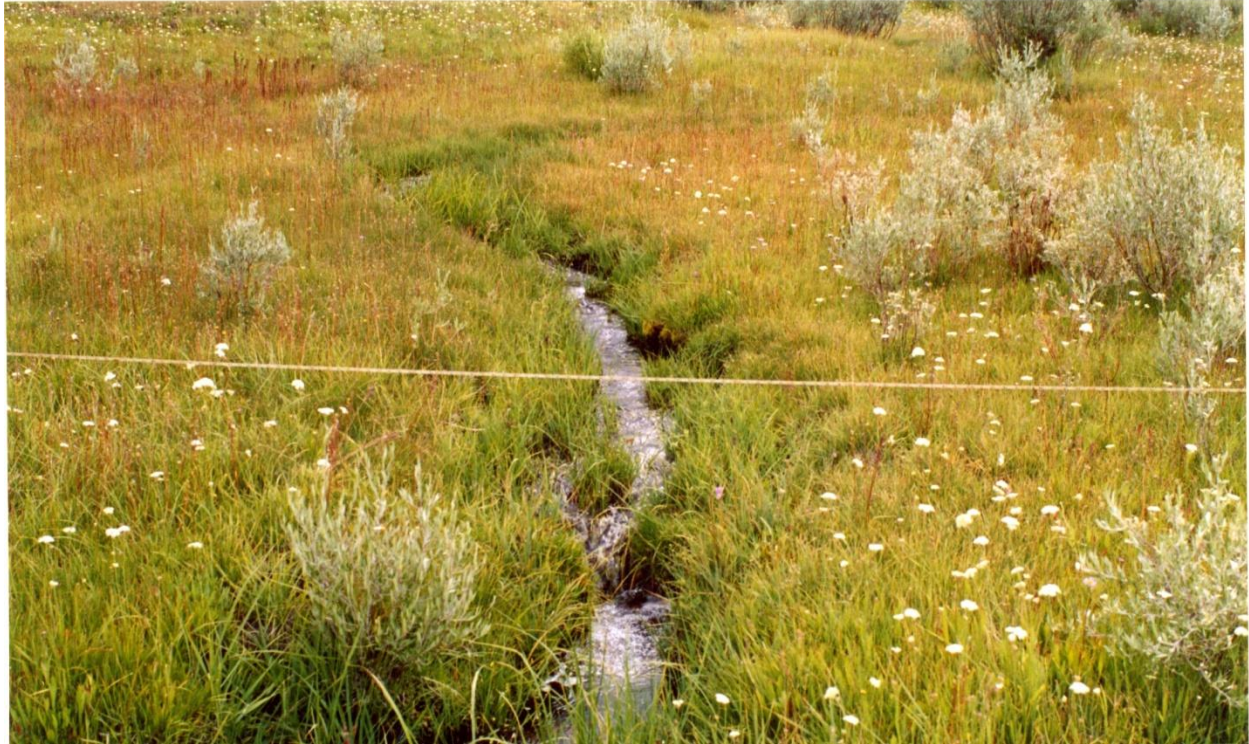
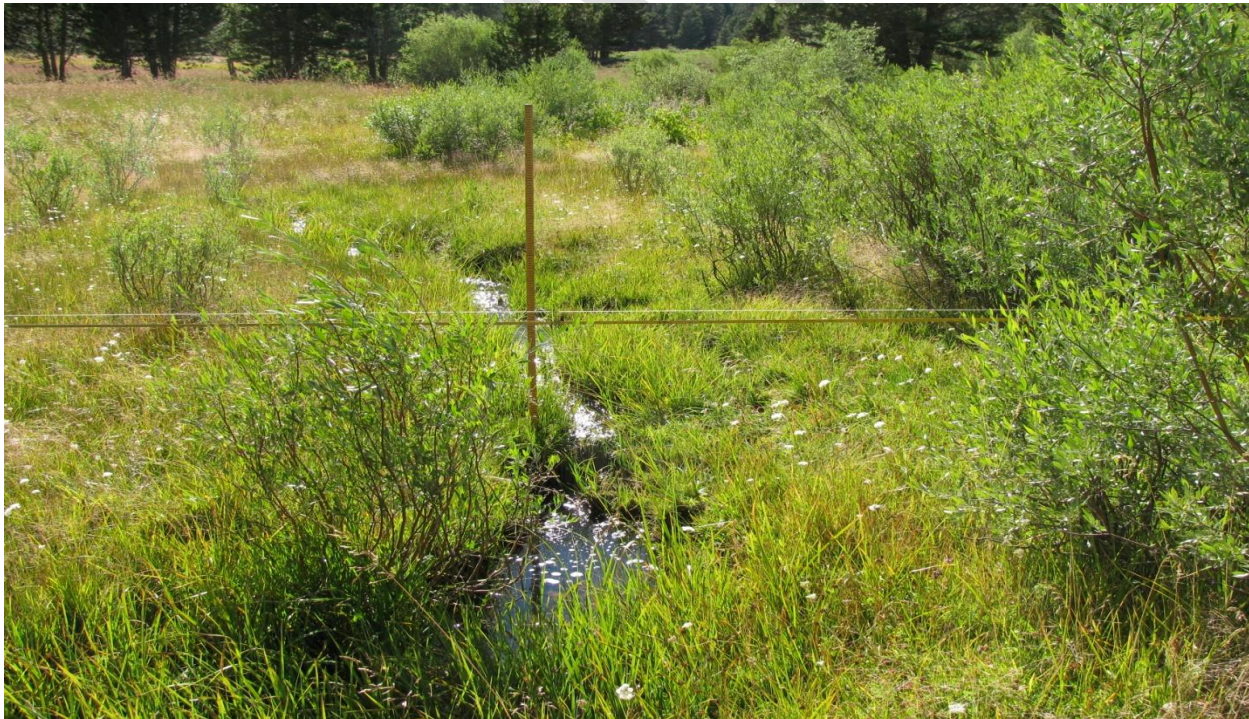
Above photo: Head cut 349 (HC 349) Upper Strawberry Creek below Templeton Cow Camp, July 2003. A small in-stream head cut in a well vegetated meadow with deep organic soil horizon and root depth. **Below photo:** HC 349 Upper Strawberry Creek with photo re-taken August, 2010. Head cut has moved little since 2003, 0.33 meters. At this site this is likely due to peak stream flows tending to access well-vegetated floodplain which dissipates stream energy, along with strong vegetative cover and deep, rooted organic horizon that slows HC migration rate. This type of site is resistant to in stream erosion and impacts.
